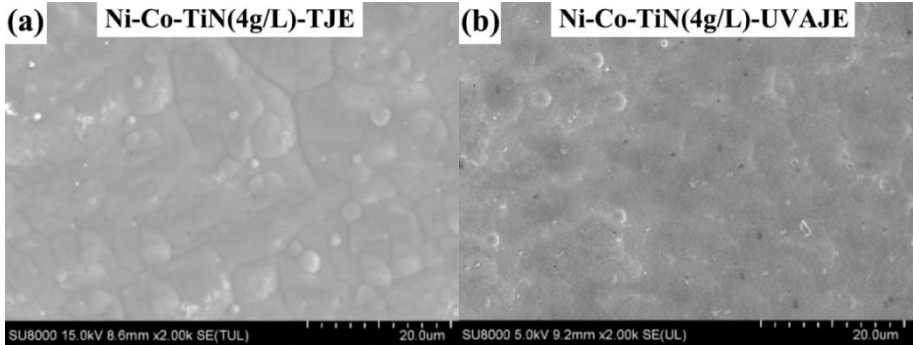
Fig. S8 SEM images of the different Ni-Co-TiN coatings after salt spray test.
