Tribo-corrosion behavior of Zn-Ni-Cu and Zn-Ni-Cu-TiB₂ coated mild steel

Abstract In this investigation, Zn-Ni-Cu and Zn-Ni-Cu-TiB₂ were coated on a mild steel specimen using a high velocity oxy fuel thermal spray (HVOF) process. The surface morphology and coated powder distribution of coated specimens were characterized using scanning electron microscope (SEM), energy dispersive spectroscopy (EDS), and X-ray-Elemental mapping. The pin-on-disc (ASTM G99-17) method was used to examine the wear resistance of the coated and uncoated mild steel specimens. Both coated Zn-Ni-Cu and Zn-Ni-Cu-TiB2 on mild steel saw reduced wear volume loss than uncoated mild steel. The coated samples of Zn-Ni-Cu and Zn-Ni-Cu-TiB2 on Mild Steel were put through a scratch test to determine the adhesion strength of the coating with the substrate. The adhesion strength of coated Zn-Ni-Cu and Zn-Ni-Cu TiB2 mild steel was higher than that of untreated mild steel, indicating a solid link between the coating and substrate and minimal delamination. Using the Vickers hardness test to measure the hardness caused by the coating, it was shown that coated samples of Zn-Ni-Cu and Zn-Ni-Cu-TiB2 coated mild steel had sign

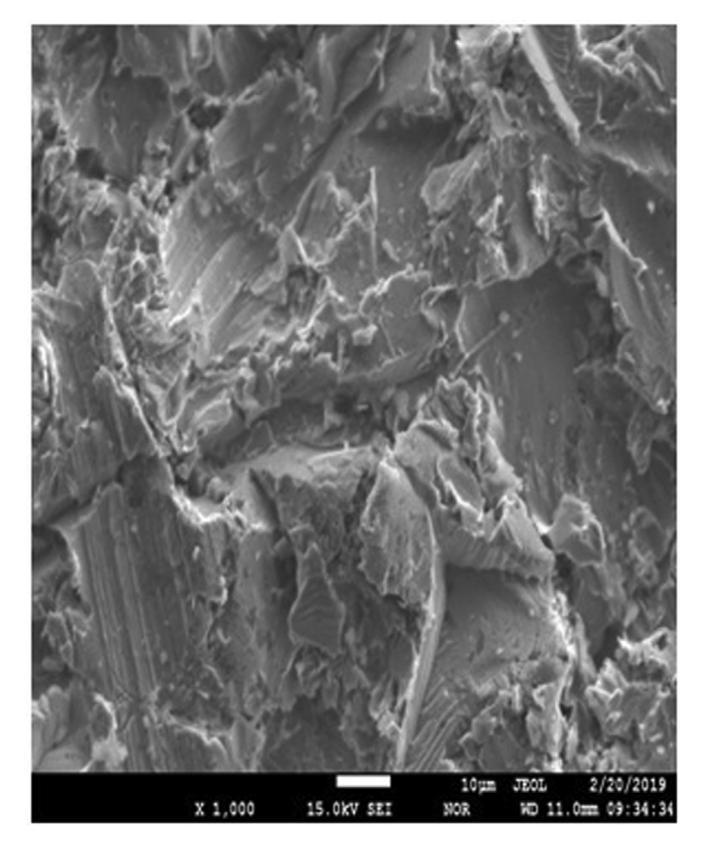
Fig. 1 Shows EPMA and EDS of uncoated mild steel at X400.

For a better understanding of uncoated mild steel specimen surface analysis. The characterization was undertaken using EPMA (JEOL EDS System, Japan coupled EDS) analysis. The micrograph showed an uneven and boisterous surface created by grit blasting necessary for better adhesion of the coating.EPMA of the uncoated sample is given in Fig. 1.

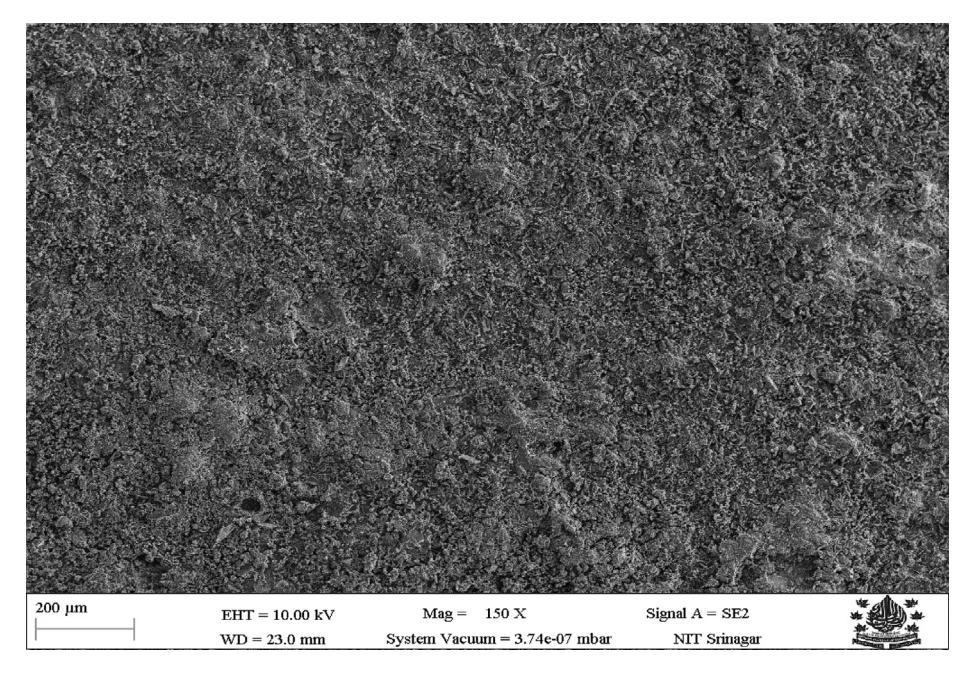
Fig. 2 Shows an SEM image of coated (Zn-Ni-Cu on mild steel).

SEM (SEM, Model, Nova NANO SEM 430) coupled with EDS (EDAX, USA Apollo 40) was used to analyze the coated samples, SEM analysis of coated surface showed a conformably coated surface with globules on the surface. The

coating is thick and fully spread. Due to the high velocity of HVOF thermal spray leading to insufficient melting of powder particles, several globules can be observed on the coated surface of the SEM micrograph. Fig. 2 shows the surface SEM of surface coating 1 (Zn-Ni-Cu on mild steel). X-ray Spectroscopic analysis helped to have better insights into coated powder distribution on the surface shown in Fig. 3. Zn being ample is almost fully spread across the surface. Designated by red color at 20 µm magnification. While Ni is represented by green color and Cu is represented by blue color being also presents as an isle preferably because of agglomeration of powder during coating that non-uniform pattern of coated powder is seen in elemental mapping. The Presence of Fe on the surface can be attributed due to surface diffusion from the substrate to the coating, the presence of pores is also observed in HVOF coatings, the average size of pores is 794.3 nm (Zhang et al., 2020). However, the diffusion of Fe onto the surface is very less as seen from the X-ray elemental distribution designated by light blue color. Fig. 3 gives the X-ray elemental distribution of coating 1 on the specimen (Zn-Ni-Cu on mild steel).

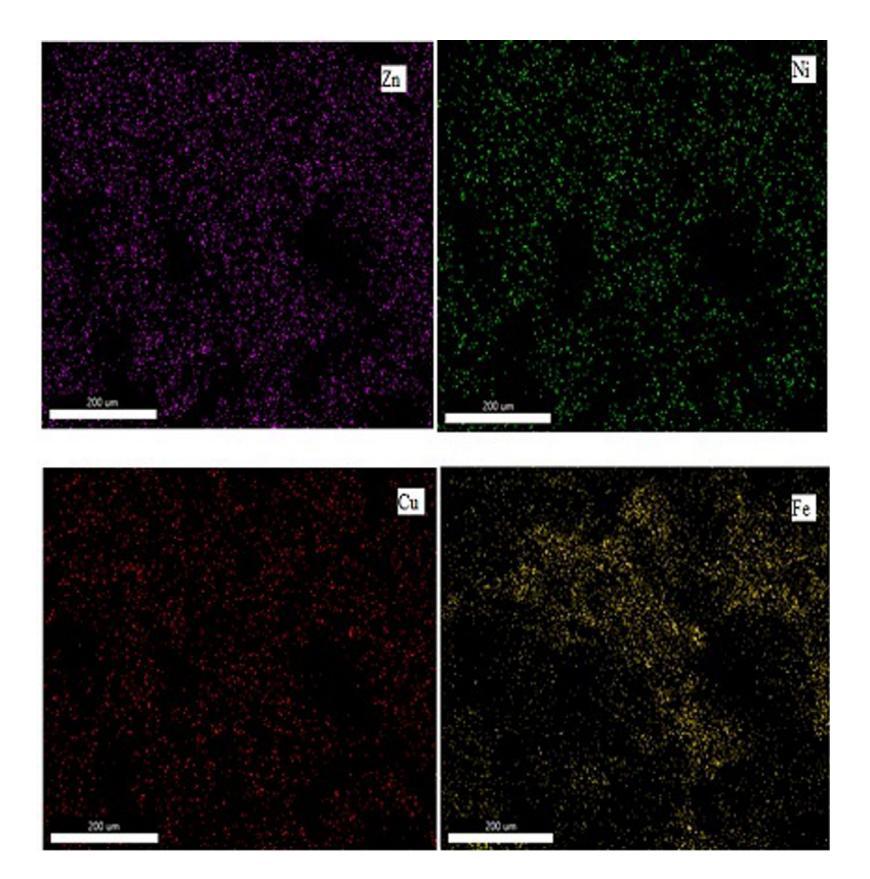
Fig. 3 Shows the X-ray elemental distribution of constituent elements of (Zn-Ni-Cu on mild steel).

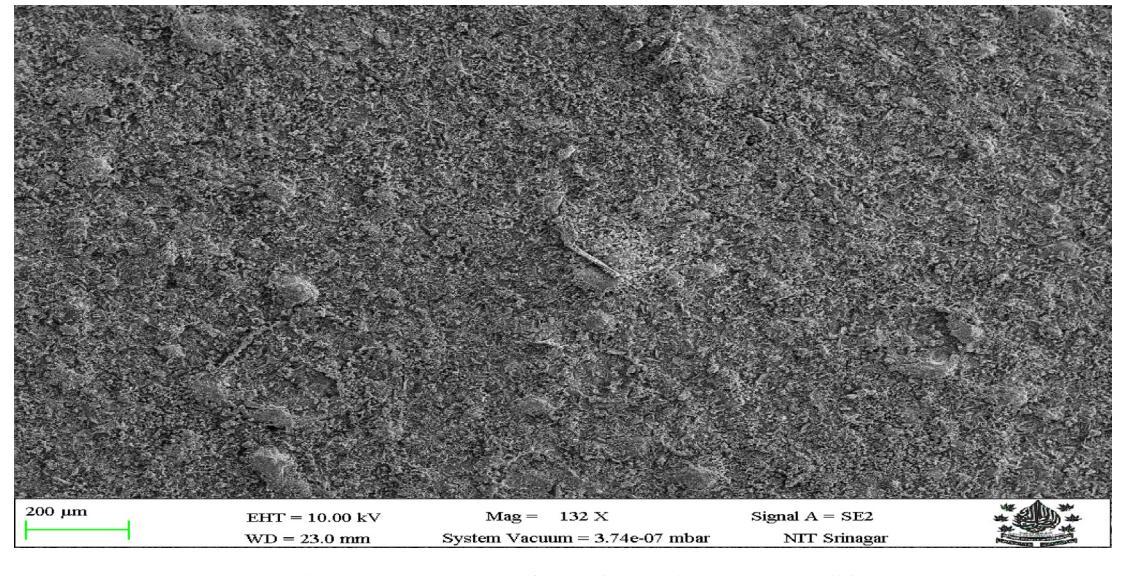
Fig. 4 Shows an SEM image of coated (Zn-Ni-Cu-TiB₂ on mild steel).

As the SEM micrograph shows coating 2 (Zn-Ni-Cu-TiB₂) is well developed and fully spread with the non-uniform pattern. however, some large globules are still present preferably due to the incomplete melting of some metal powder during the spraying process but the splatted powder has solidified into splats and overlaying each other leads to a small number of pores or voids in between them. Fig. 4 shows the SEM micro-

graph of coating 2 (Zn-Ni-Cu-TiB₂ on mild steel). Foreign contamination is absent. X-ray Spectroscopic analysis helped to have better insights into coated powder distribution on the surface. Zn is represented as the red color being ample and is almost fully spread across the surface. While Ni repre-

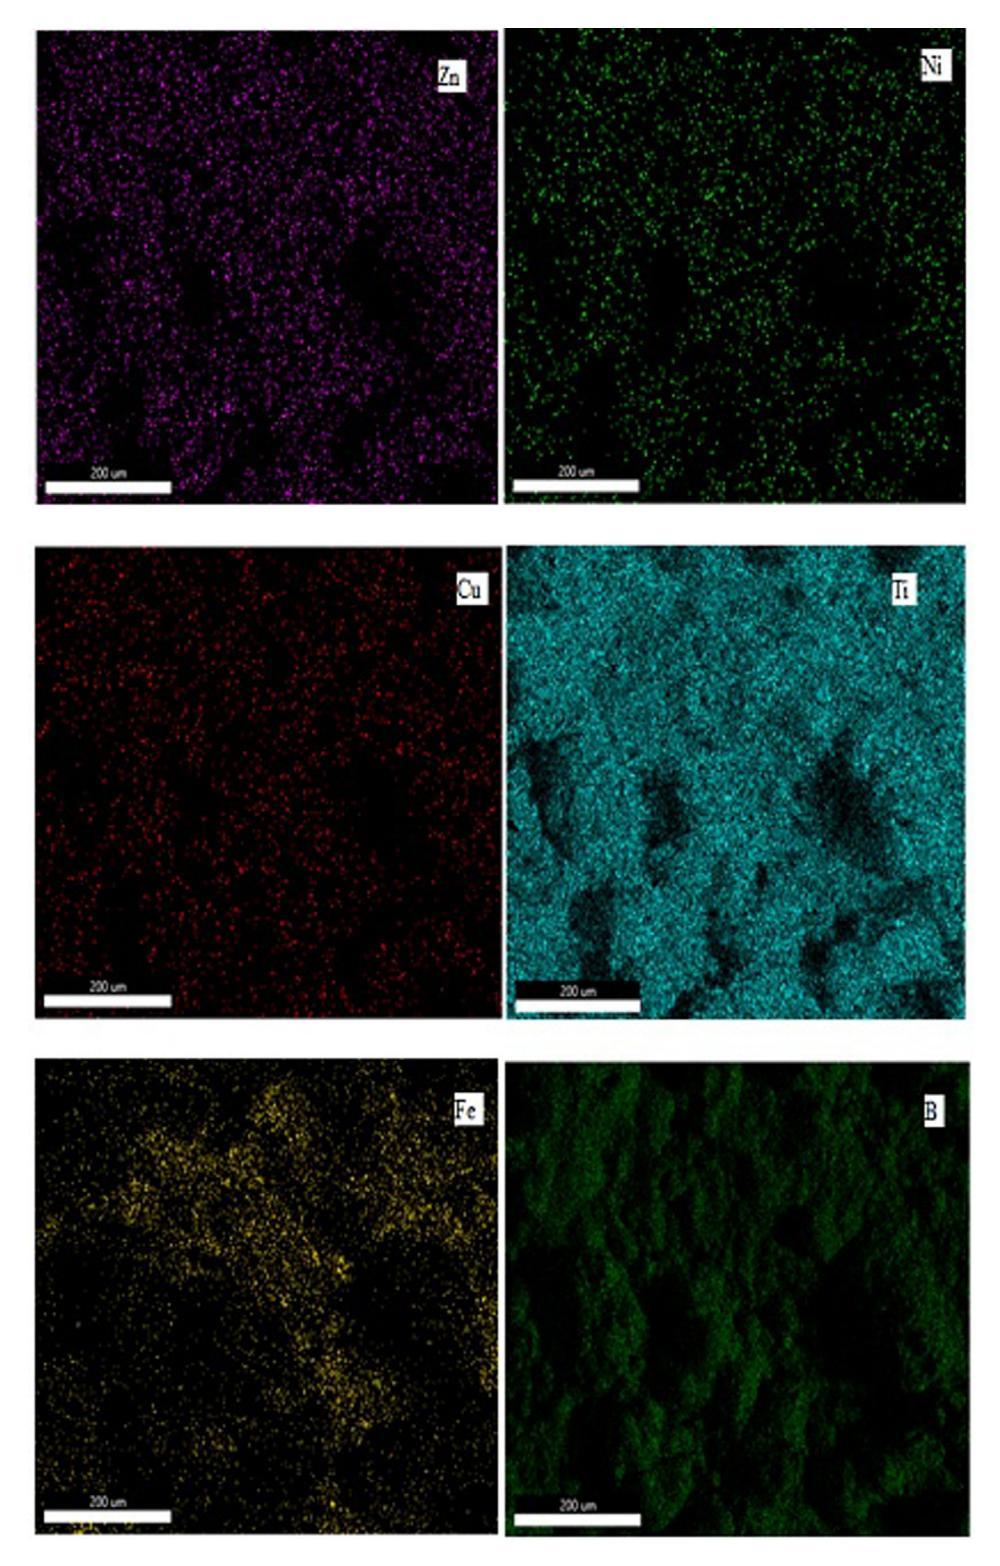
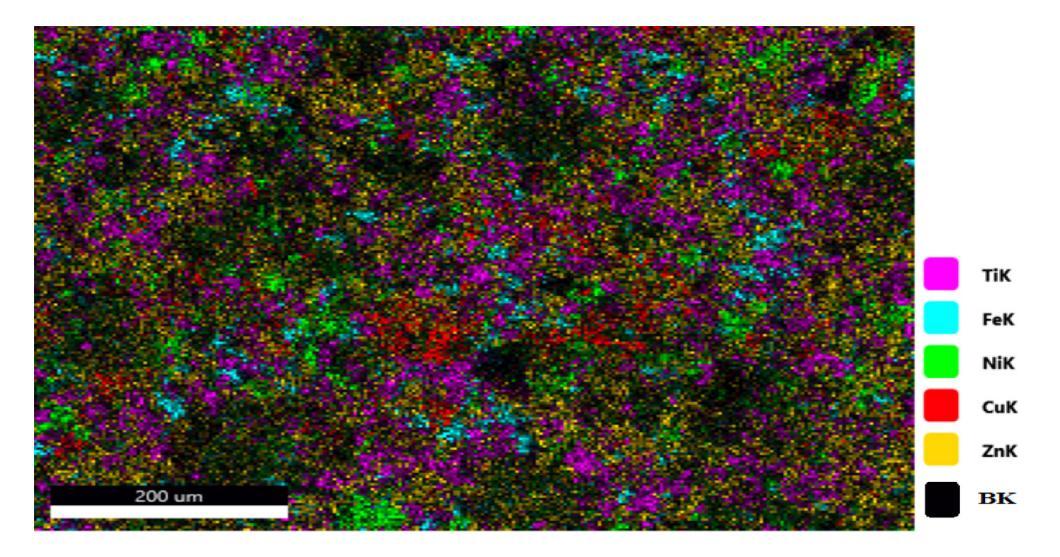
Fig. 5 Shows the X-ray elemental distribution of constituent elements of Zn-Ni-Cu-TiB₂ on mild steel.

sented by light yellow color is also spread fully along with some isle present. Cu represented by blue color is also spread but due to agglomeration it is present less uniformly eccentrically, and Ti and B represented by light blue and green respectively are also spread fully while some portions are present like

an aisle. The Presence of Fe represented by Cyan color on the surface can be attributed due to surface diffusion from the substrate to the coating and the presence of pores having 998.0 nm size (Zhang et al., 2020). TiB₂ has been found to possess a pseudogap between d-orbitals of Ti and p orbitals of B which helps it to form strong metallic and covalent bonds with other constituents of coating like Zn, Ni, Cu thereby increasing the cohesion strength of Zn-Ni-Cu -TiB₂ on mild steel (Lotfi, 2010). Fig. 5 gives the X-ray elemental distribution of coating 2 on the specimen (Zn-Ni-Cu -TiB₂ on mild steel).

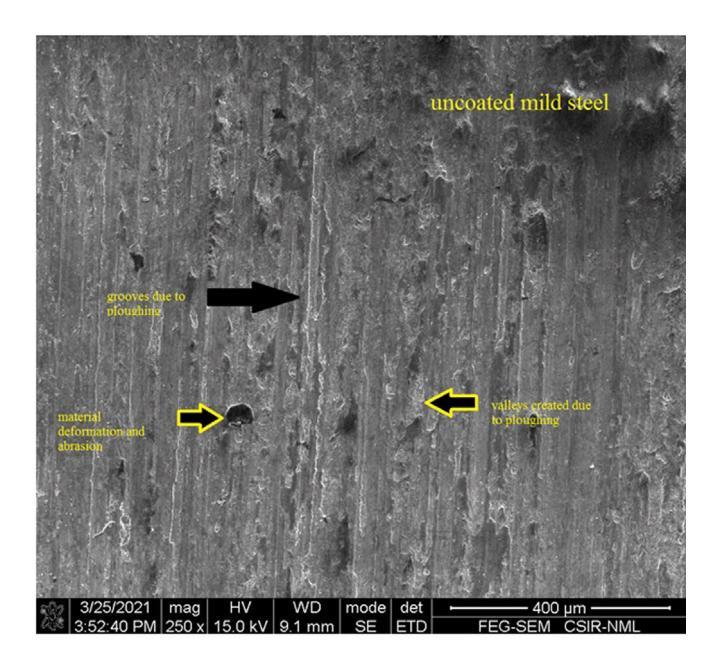
Fig. 6 Shows the FEG-SEM images of specimens after pinning on disc tribotest. Fig. 6, (a) shows pin on disc test on uncoated mild steel specimen. (b) shows the pin on the disc test on Zn-Ni-Cu coated specimen. (c) shows pin on disc test on Zn-Ni-Cu-TiB₂ coated specimen.

- (iii) The Zn-Ni-Cu and Zn-Ni-Cu-TiB₂ coatings on mild steel improved the wear resistance of mild steel. The SEM images confirmed that wear tracks and plowing, grooving, and wear debris in coated samples were minimal compared to uncoated mild steel even at high load/ high contact pressure.

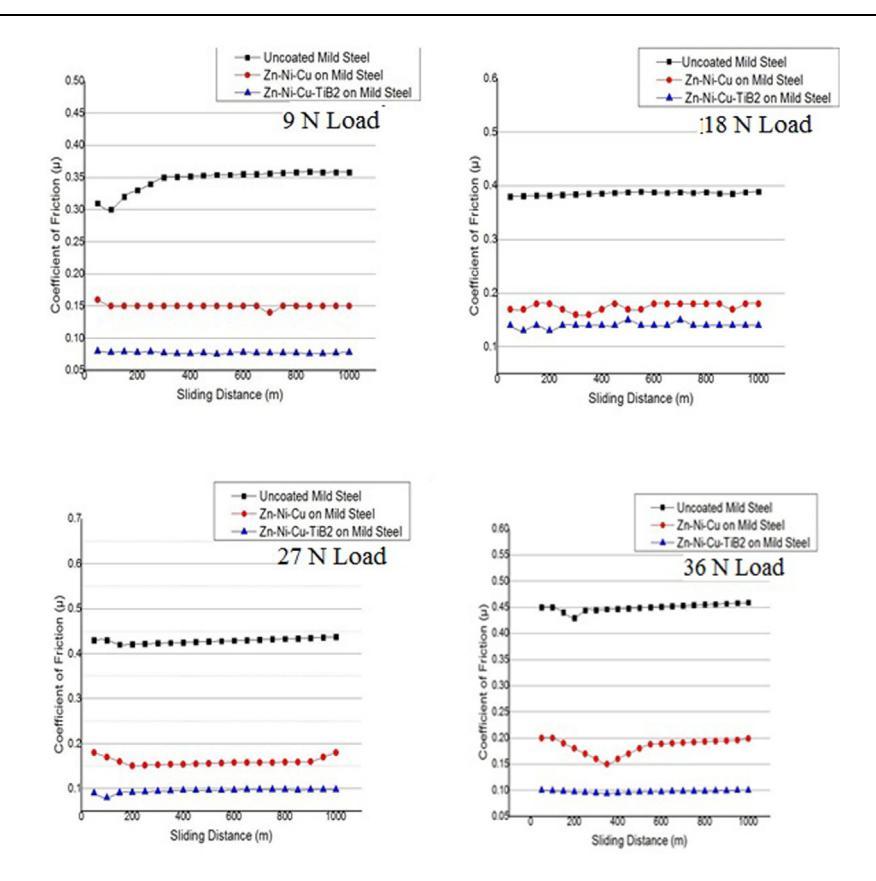
Fig. 7 Shows the coefficient of friction versus sliding distance for uncoated/coated mild steel samples.

The coefficient of friction of both uncoated and coated samples of mild steel was investigated at identical load conditions results are shown in Fig. 8. The wear test (pin on disc method)

gave a thorough insight analysis of the pin and disc interface. the pin material having lesser hardness was removed easily and its particles acted as a third body abrasive hence lowering the coefficient of friction in the interface in both coated samples of Zn-Ni-Cu and Zn-Ni-Cu-TiB₂ on mild steel compared to mild steel. At lower loads of 8 N, the coefficient of friction in uncoated mild steel is higher as compared to coated mild steel

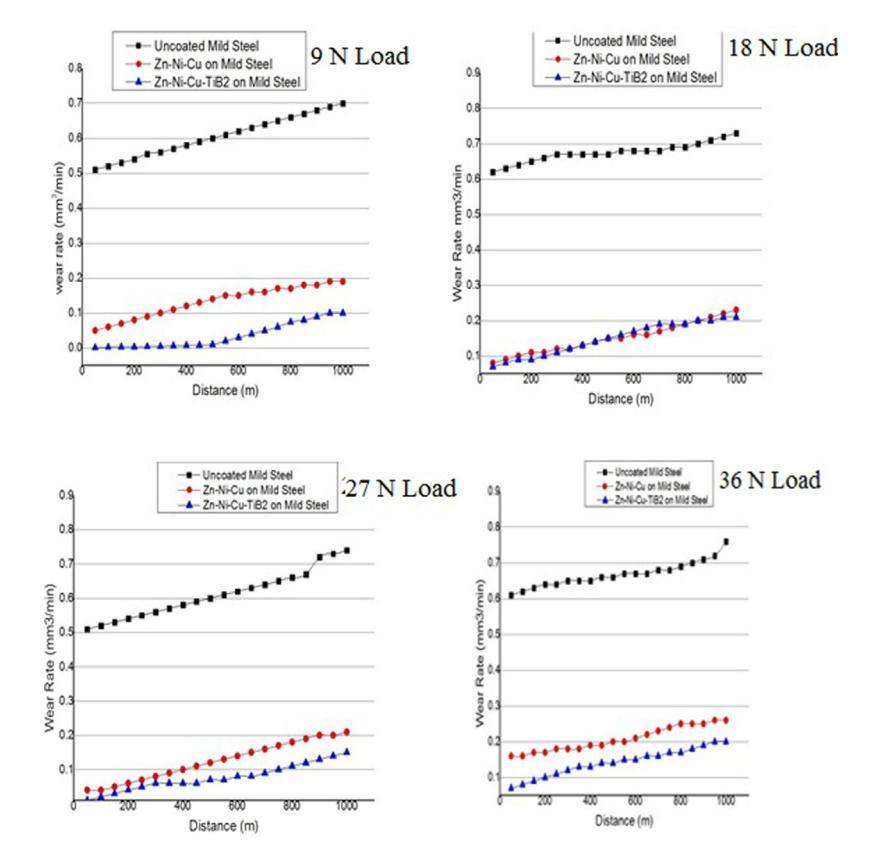
Fig. 8 Shows wear rate versus sliding distance for uncoated/coated mild steel samples.

coefficient of friction of both coated samples. Also, the wear rate of uncoated mild steel samples is significantly higher as compared to both Zn-Ni-Cu on mild steel and Zn-Ni-Cu-TiB₂ on mild steel.

A consequence of both Zn-Ni-Cu and Zn-Ni-Cu-TiB₂ on mild steel reduced the friction coefficient significantly as compared to uncoated mild steel hence helping us to understand the lower wear rate in coated samples as compared to uncoated mild steel under identical conditions. Lower coefficient of friction ≤ 0.25 for titanium alloys has been reported (Bolelli et al., 2015). Figs. 7, 8 shows the coefficient of friction and wear rates of all specimens during the tribology test. Fig. 9 shows 3 D profilometer images of specimens after pin on disc experiment at 32 N Load.

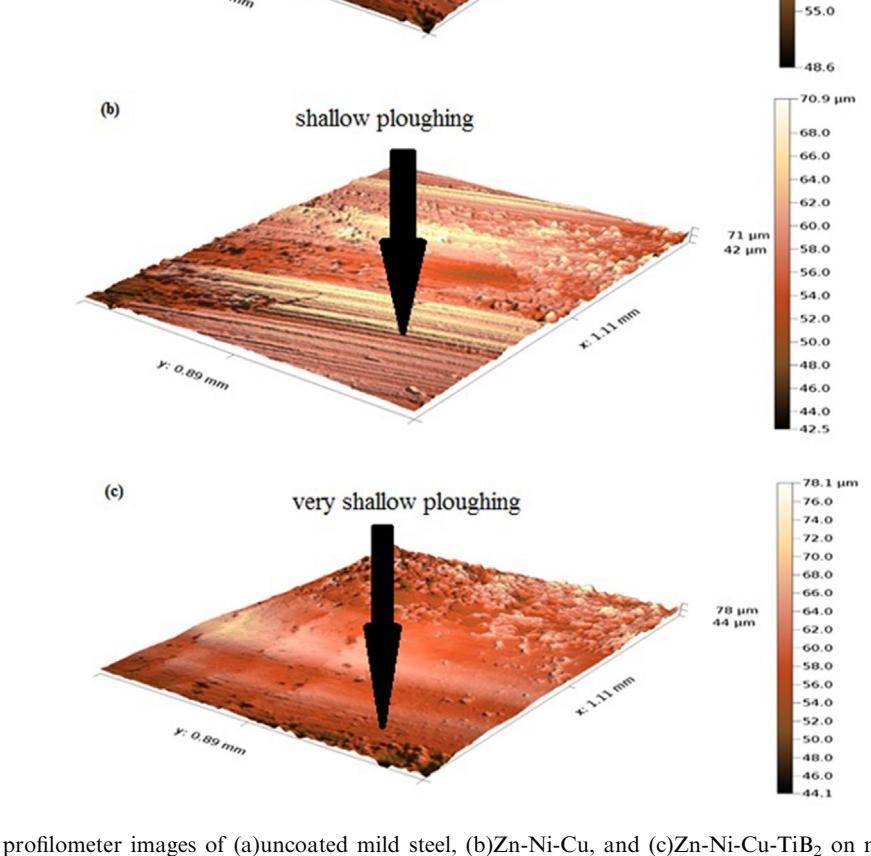
Fig. 9 Shows 3D profilometer images of (a)uncoated mild steel, (b)Zn-Ni-Cu, and (c)Zn-Ni-Cu-TiB₂ on mild steel after pin on disc experiment at 32 N load.

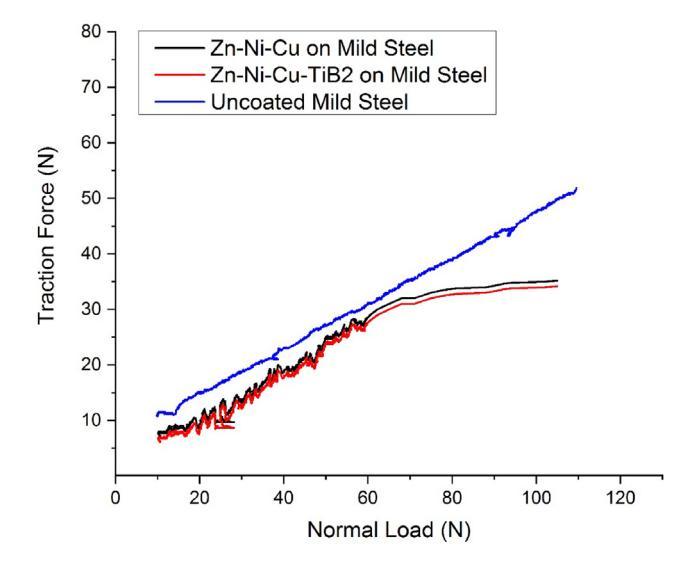
Fig. 11 Shows traction force versus normal load for uncoated/coated samples.

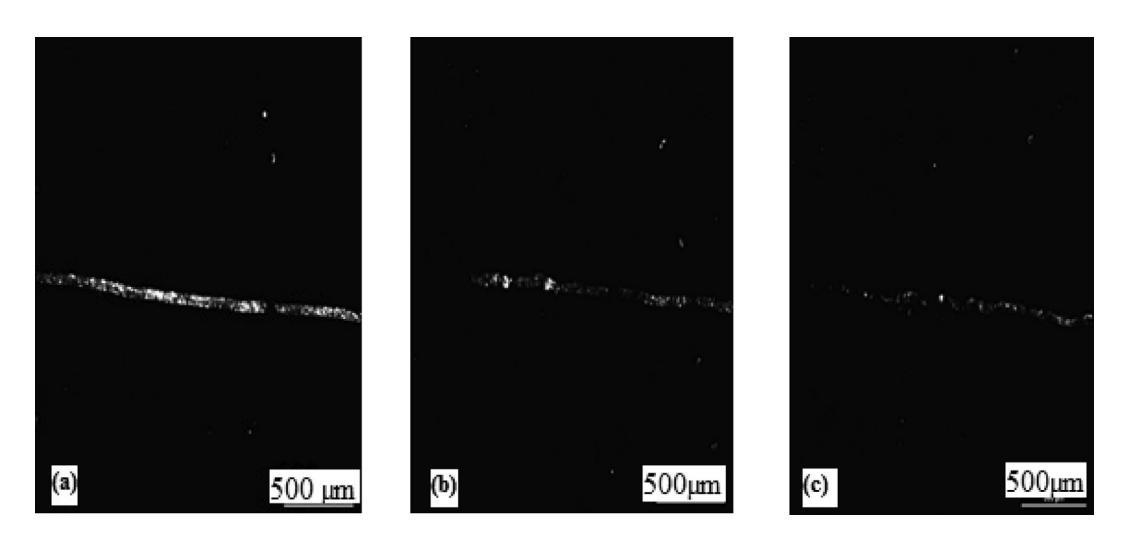
Fig. 10 Shows the optical micrographs of the Scratch test at 40 N, 500 μm magnification. (a) uncoated mild steel,(b) Zn-Ni-Cu on mild steel, (c) Zn-Ni-Cu-TiB₂ on mild steel.

To determine the scratch resistance of the coating, the scratch test was performed for sliding wear conditions. For this purpose, an adhesion scratch tester (Du-Com instruments, India) was used having a diamond C indentor with having tip radius of 200 μ m, a stroke length of 5 mm, and a contact Load rate of 2 N/mm, the scratch velocity of 0.1 mm/s. Normal load varied from 10 N to 40 N. The Scratch width of coating 1 (Zn-Ni-Cu

on mild steel) was 110 µm. For coating 2 (Zn-Ni-Cu TiB₂ on mild steel) it was 62 µm.while for uncoated mild steel it was 505 µm at 40 N Load. Fig. 10 shows the optical images of (a) uncoated mild steel at 10 N load, (b) Zn-Ni-Cu on mild steel at 40 N, and (c) Zn-Ni-Cu-TiB₂ on mild steel at 40 N. Fig. 11 shows the traction force verses normal load for uncoated/coated specimens. The traction increases linearly for uncoated samples inferring higher friction. while for coated samples it remains constant after certain load inferring constant coefficient of friction reiterating that coating has a lubrication effect as well during rubbing action. The data values of the scratch test are shown in Table 6. Tensile cracks can be seen in optical micrographs of both coated samples as compared to mild steel inferring better surface adhesion of coating with substrate. Lower conformal cracks in coated samples also infer the same thing (Bolelli et al., 2015). Also, the traction force measured during the scratch test is significantly more in uncoated sam-

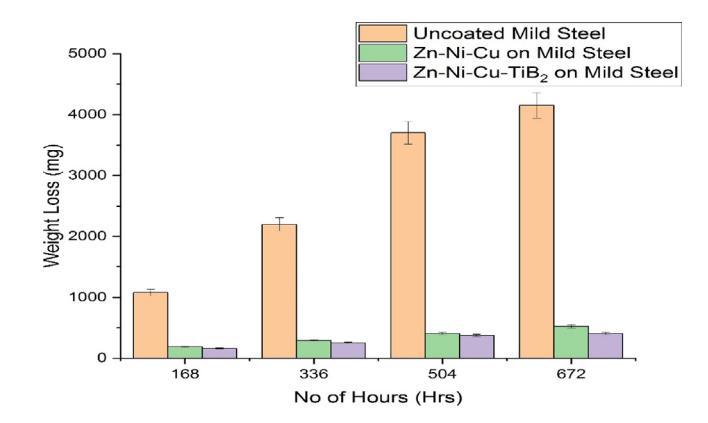
Fig. 12 Shows weight loss results of uncoated/coated samples for 672 hrs in 0.5 M HCl solution.

Mild steel is very prone to corrosion attack, the corroded mild steel parts are cleaned using HCl or H₂SO₄ to remove scales on the surface. However, the presence of SO_4^- and Cl^- ions in these acids can further increase the rate of corrosion on the mild steel surface. Hence we tested coated mild steel samples in a 0.2 M HCl environment to ascertain the effectiveness of coatings (Panich, 2007). HCl was used as a corrosive medium because it is amply used in food processing industries and oil and natural gas industries for cleaning of mild steel equipment leading to corrosion of cleaned parts eventually. The size of the specimens was (1016 mm \times 635 mm \times 2.0 mm). This test was performed at 25 °C. Corrosion studies on mild steel have been undertaken in the past at various concentrations of HCl because it has been reported to be very corrosive to most metals and their alloys (Federici et al., 2017; Mikula et al., 2007). It was found that mild steel showed appreciable corrosion impregnation and mass loss at 0.5 M HCl. Considering these facts we tried to investigate the effectiveness of our two coatings (Zn -Ni-Cu) and (Zn-Ni-Cu-TiB₂) on mild steel and compare its results with that of uncoated mild steel specimen. For this Coated Specimen 2 (Zn-Ni-Cu on mild steel), specimen 3 (Zn-Ni-Cu -TiB₂ on mild steel), and specimen 1 uncoated mild steel of the same dimension was used. 0.5 M HCl was prepared and poured in equal quantities into beakers. Later on, specimens 1, 2, and 3 were weighed using (LIBROR AEG 120) and checked for any pores and cracks. A pH meter (P-100 Cole Parmer) was used to measure the pH of the solution (pH = 3). Later samples were put into beakers and removed every 7 days (168) Hrs. Cleaned with distilled water, dried, and later weighed. The sample solution was changed every 7 days with pH, being measured every 7 days. It was clear that corrosion was initiated within the first few minutes of immersion into 0.2 M HCl. However the rate varied significantly in uncoated mild steel specimens and it was clear that material particles could be seen floating in an uncoated mild steel beaker within a few hours after immersion, while the coated samples showed significant resistance to corrosion attack. The mass loss for specimen 1 uncoated mild steel was 4159 mg, specimen 2 (Zn-Ni-Cu On mild steel) at the end of the experiment was 523 mg and specimen 3 (Zn-Ni-Cu -TiB2 on mild steel) was 406 mg, and for at the end of 28 days (672) hrs. No protective black (Fe₃O₄) layer could be formed on an uncoated mild steel surface in an acidic medium which could save the underneath metal from further attack (Souza and Neville, 2005). one interesting accidental observation was made by placing uncoated mild steel directly over the 0.2 M HCl beaker having no physical contact between the two, the uncoated mild steel specimen developed corrosion after observation at 24 hrs. black and brown rust was present on the surface of the sample is very loosely bonded and was removed by gently blowing some air over the sample. Although the exact mechanism of this is not known nor reported by any literature review, it could be attributed due to the volatile vapors of 0.2 M HCl which could have initiated the rust in the specimen when not being in direct contact. The lower mass in specimen 2 is due to better surface adhesion with substrate and TiB₂ being itself more resistant to corrosion thus helping improve the existing resistance of the metal coating. HVOF-coated Ni also has good corrosionresistant behavior (Souza and Neville, 2005). Fig. 12 and Table 7 show the results of the test.

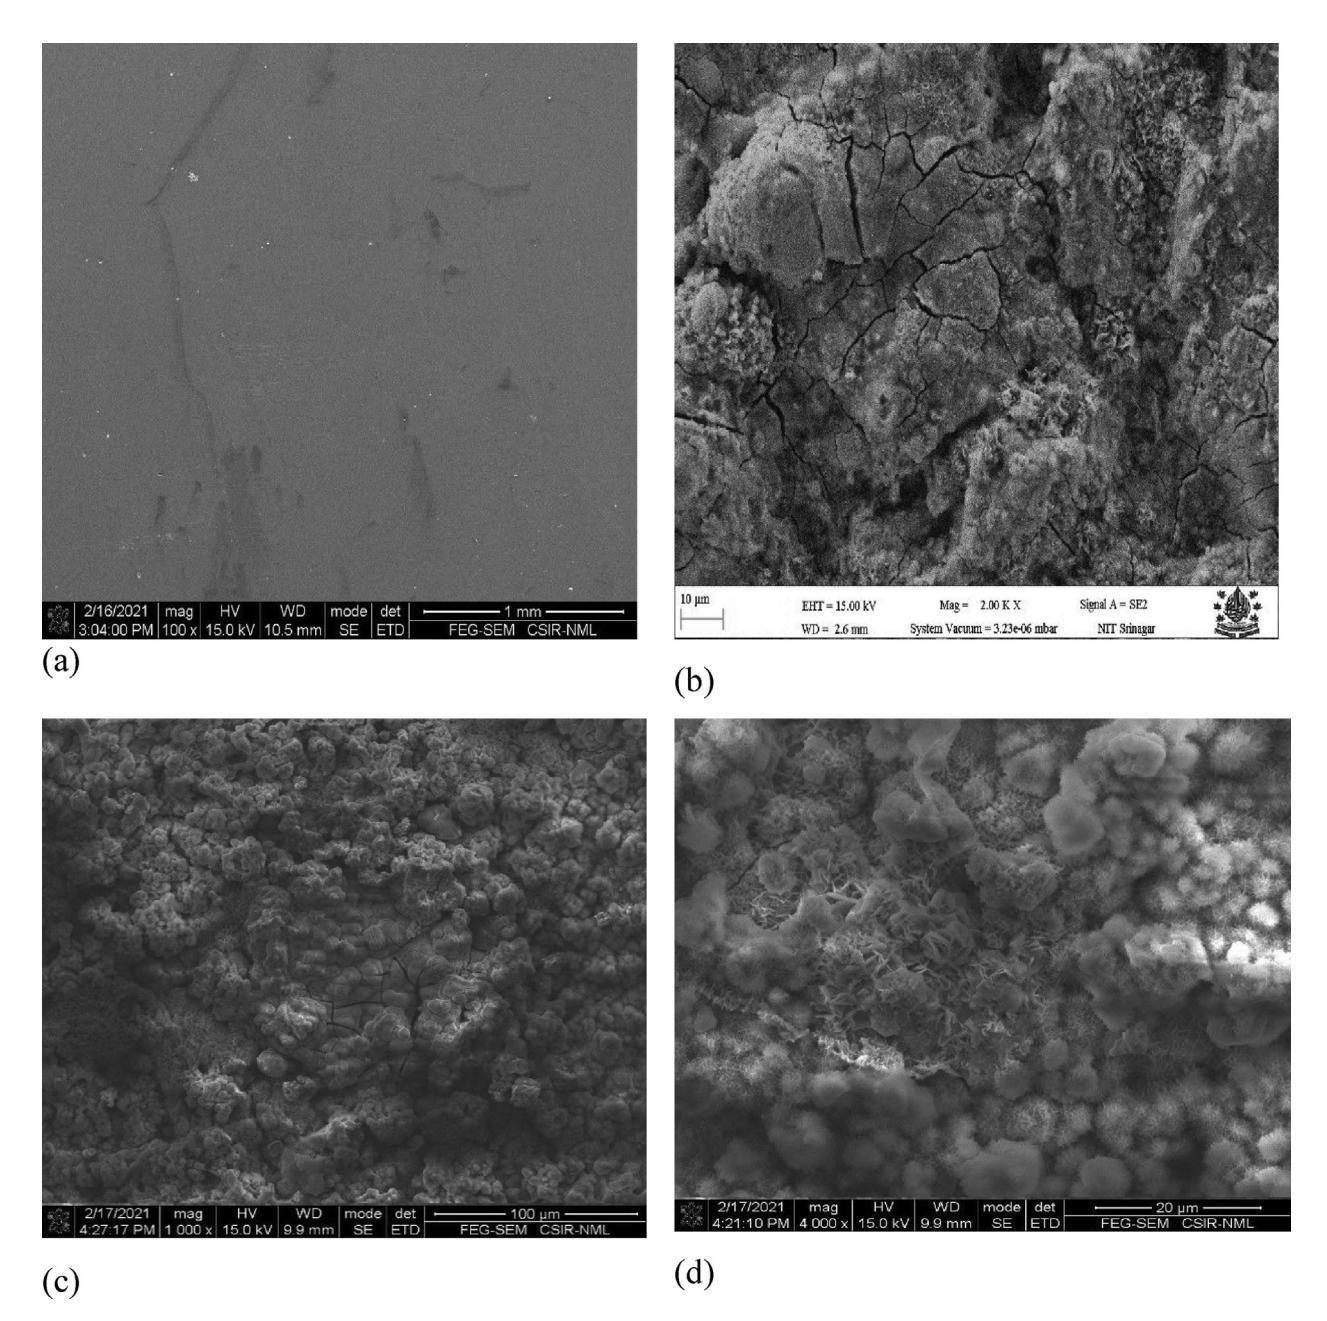
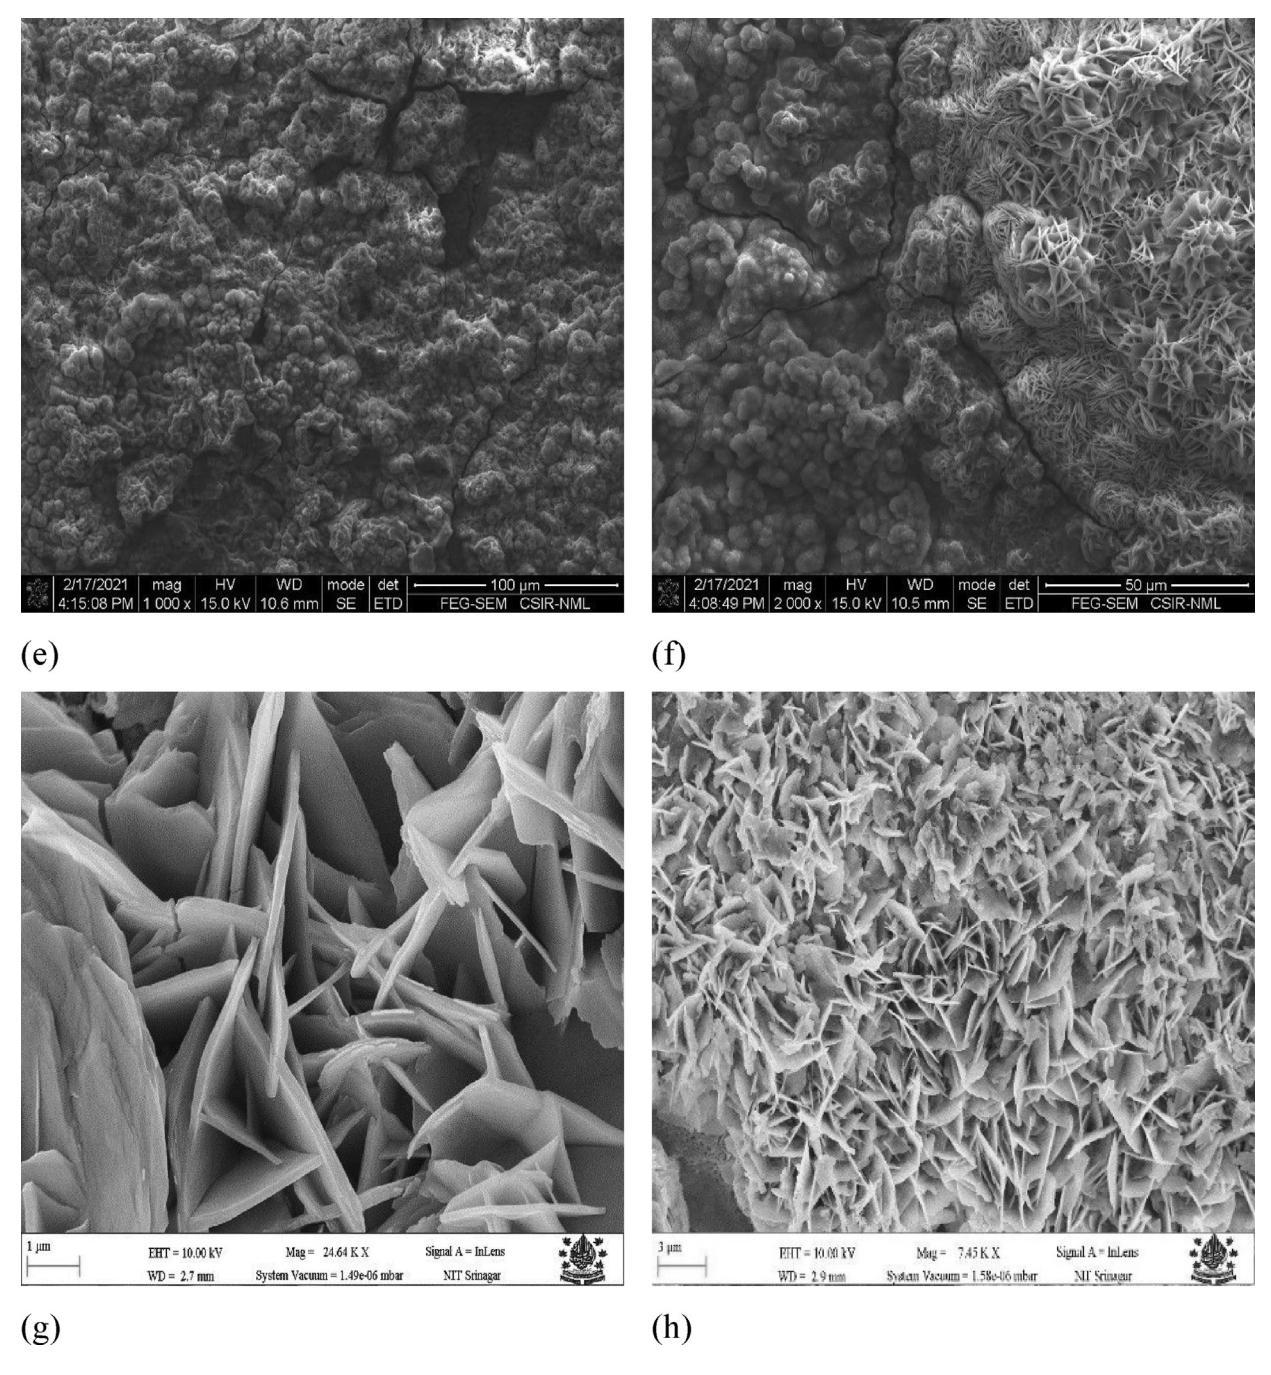
Fig. 13 Shows the FESEM/FEG-SEM images of specimens before and after the 0.5 M HCl immersion test. Fig. 8 (a,b) shows uncoated mild steel surface before and after the 0.5 M HCl immersion cycle test.(c,d) shows Zn-Ni-Cu coated mild steel surface before and after 0.5 M HCl immersion cycle test. (e,f) shows Zn-Ni-Cu-TiB₂ coated mild steel surface before and after 0.5 M HCl immersion cycle test.(g,h) shows uncoated mild surface at higher magnification after 0.5 M immersion cycle test.

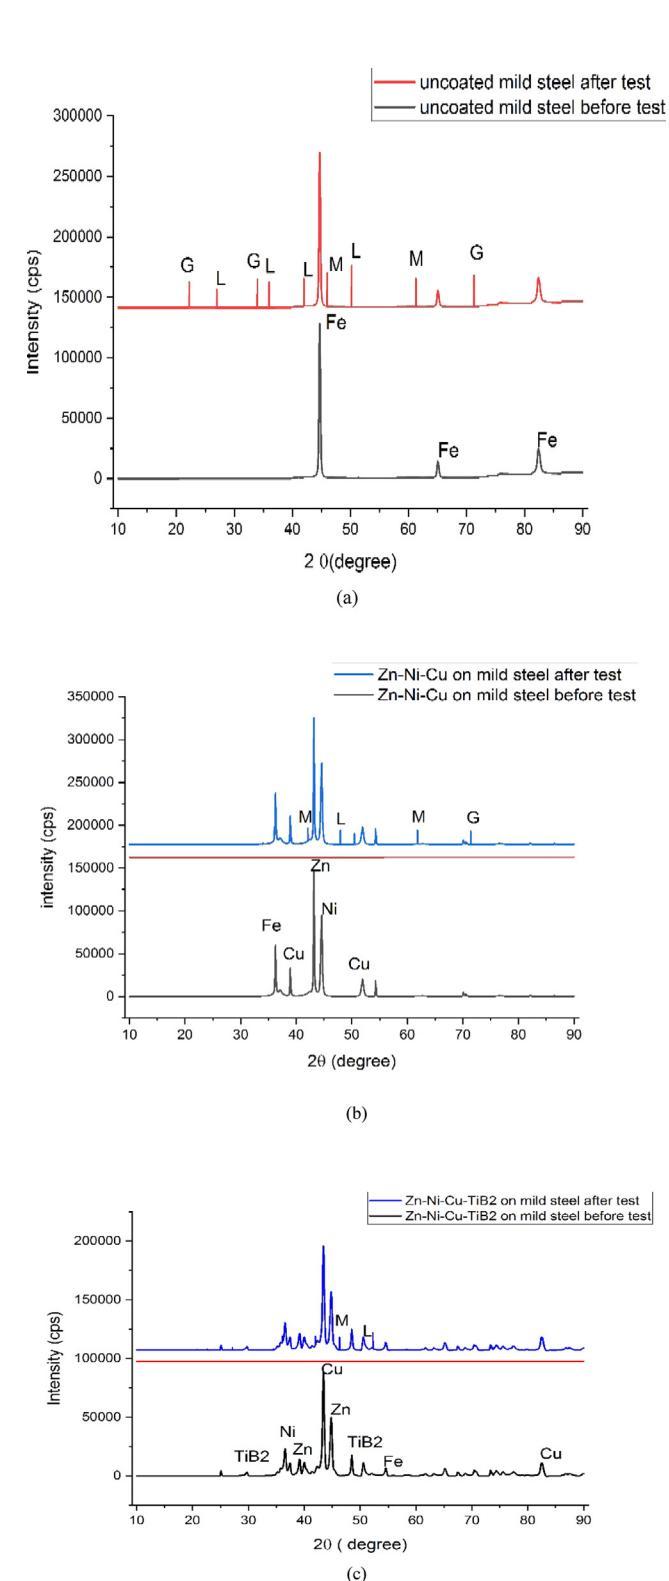
Fig. 14 Shows XRD analysis of (a)uncoated mild steel (b) Zn-Ni-Cu on mild steel (c) Zn-Ni-Cu-TiB₂ on mild steel. L = Lepidicrocite, M = Magnetite, G = Geothite.

For recognition of corrosion products formed during immersion cycle test (0.5 M HCl,672 hrs). The immersion cycle test samples were subjected to XRD analysis (Rigaku, smart lab). Quantifiable X-ray analysis designated the primary corrosion products were Goethite, Magnetite, and Lepidocrocite. In uncoated mild steel, all forms of rust(Goethite, magnetite, lepidocrocite) and in major proportions were found. Both Zn-Ni-Cu and Zn-Ni-Cu-TiB₂ on mild steel showed little quantity and few kinds of rust only. A detailed Xrd analysis is given in Fig. 14(a,b,c).

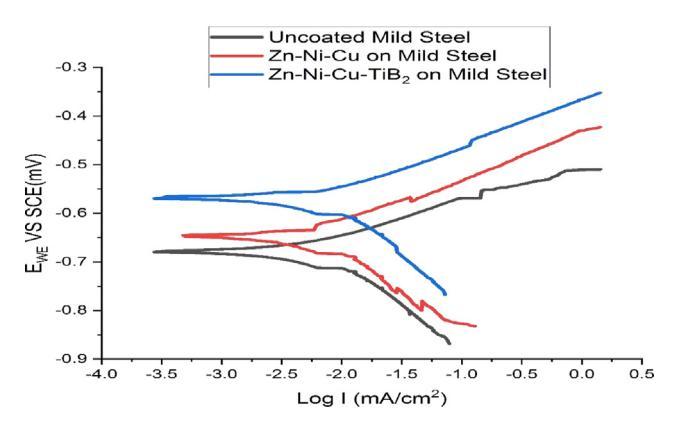
Fig. 15 Shows the Tafel plot of uncoated/coated samples in 0.5 M HCl solution.

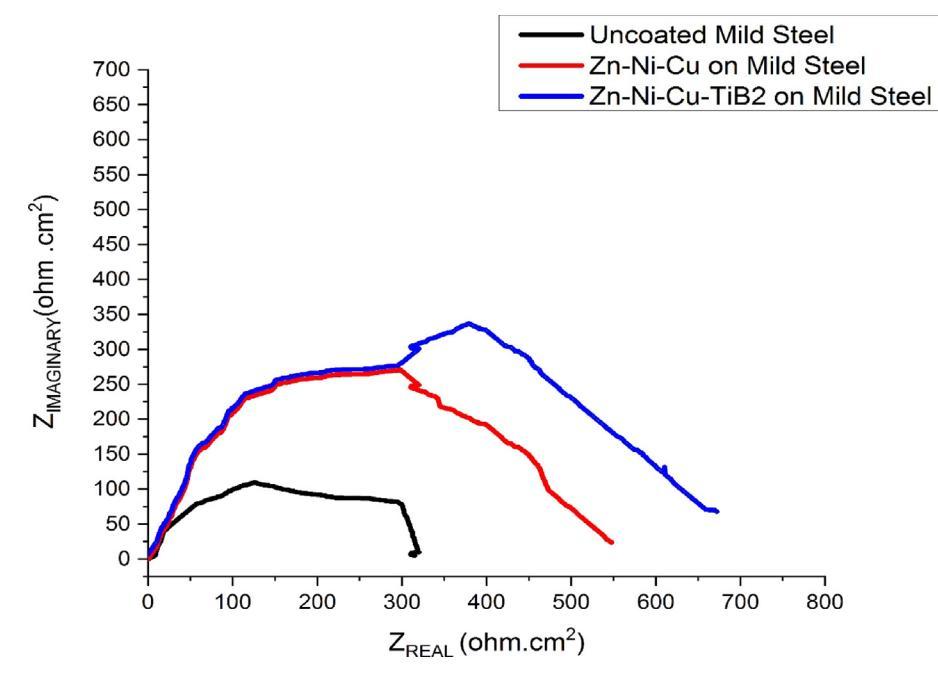
Fig. 16 Shows the Nyquist Plot of Uncoated/Coated surfaces in 0.5 M HCl.

Storozhenko et al., 2017). Fig. 16 shows the semicircular nature of both coated curves at lower and high-frequency regions. Minimum C_{PE} values for both coated surfaces also suggest that the barrier effect is effectively being provided by the coating possibly because of the formation of a protective layer of Zn(OH)₂, TiO₂ on the surface of the coating (Orubite-Okorosaye et al., 2007; Noor and Al-Moubaraki, 2008; Seidu and Kutelu, 2013). The mechanism of corrosion occurring on the coated surface is because of ionic charge movement. The impressed voltage across the interface leads to storage of charge and later aligning that charge across the interface leading to corrosion (Moretti et al., 2013; Bolelli et al., 2015). The maximum impedance of uncoated mild steel is 100 (Ω .cm²), while for Zn-Ni-Cu on mild steel maximum impedance value is 275 (Ω .cm²), for Zn-Ni-Cu-TiB₂ on mild steel its value is maximum, 350 (Ω .cm²). Bode plots shown in Fig. 17 indicate that both coated surfaces have maximum phase angle at medium frequency range, Zn-Ni-Cu on mild steel has \emptyset value of 62^0 and Zn-Ni-Cu-TiB₂ on mild steel has \emptyset value of 65⁰ inferring corrosion product film is stable and intact. Phase angle decreases with increasing frequency. Zn-Ni-Cu and Zn-Ni-Cu-TiB2 coatings on mild steel have been found to be corrosion resistant in alkaline medium as well (3.5 %NaCl solution) (Ali and Ahmad, 2022a,b; Shet et al., 2021; Bhat et al., 2021; Bhat et al., 2020; Bhat et al., 2021; Bhat et al., 2020).

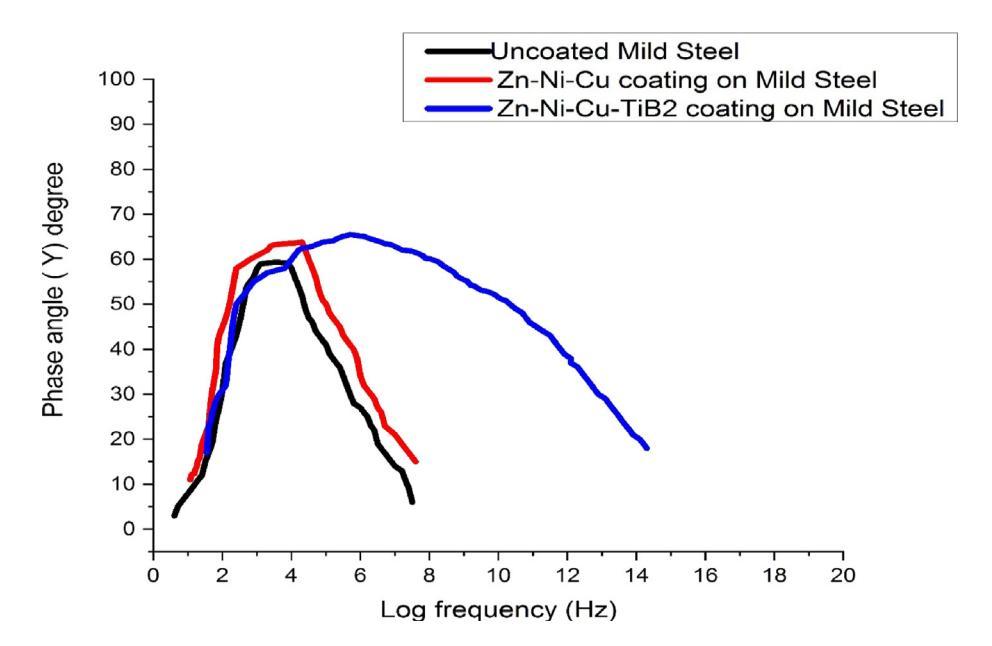
Fig. 17 Shows the Bode Plot of Uncoated/Coated surfaces in 0.5 M HCl.

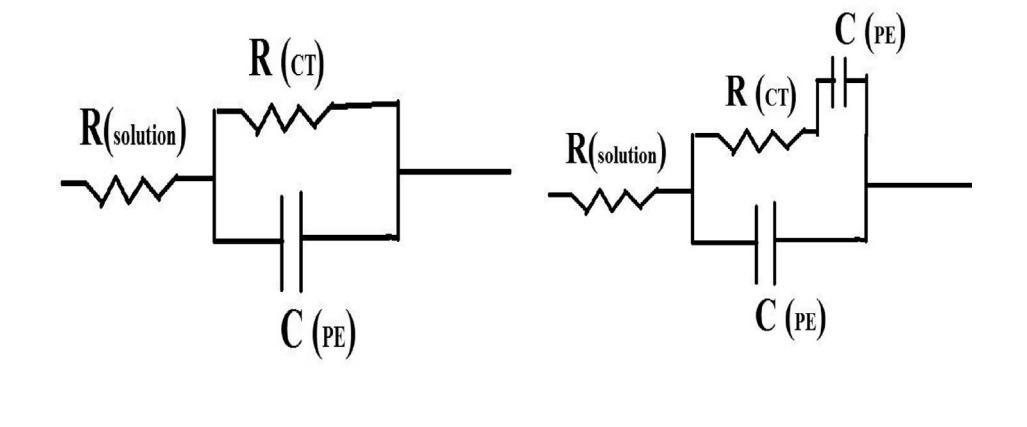
Fig. 18 Shows an Equivalent circuit (EIS) for (a) Uncoated mild steel in 0.5 M HCl solution and (b) Zn-Ni-Cu and Zn-Ni-Cu-TiB₂ on mild Steel in 0.5 M HCl solution.

0.5 M HCl, this would help us correlate the analysis in standard manner. The values obtained during the EIS test are given in Table 9. The equivalent Randles circuit is shown in Fig. 18, where.

ECM modeling software uses EIS data and analyses it for circuit elements. Fig. 18(a) shows ECM results for uncoated mild steel using the above EIS data. Fig. 18(b) shows ECM results for coated mild steel. For coated samples having imperfections and pores $R_{\rm CT}$ and $C_{\rm PE}$ are in series.
